McMinn Metal on Metal Resurfacing

Risk Factors for Failure

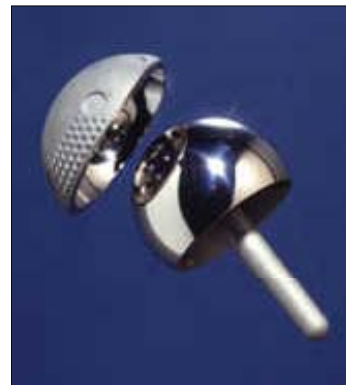
- Non surface coated press-fit femur and cup
 - Both components were cobalt chrome
 - 70 hips beginning in 1991 with ave f/u 50 mo
 - 61 satisfactory and 6 (8.6%) with aseptic loosening

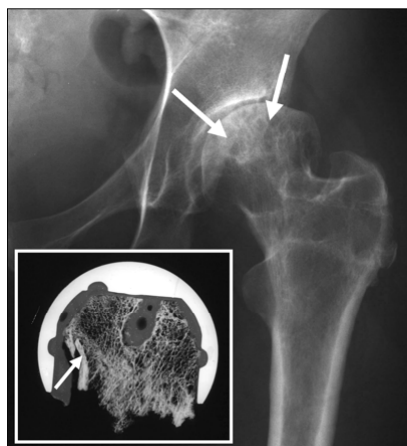
Cystic changes

- Varus of femoral component **CTQ**
 - Failed femurs - 128° (110°-148°)
 - Non failed femurs – 136.2° (111°-163°)
 - p=.0255
- Large cystic areas of head (5 hips) **CTQ**
- Failure to seat femoral component (3) **CTQ**
- Femoral notching
 - Amstutz JBJS Sept 2004

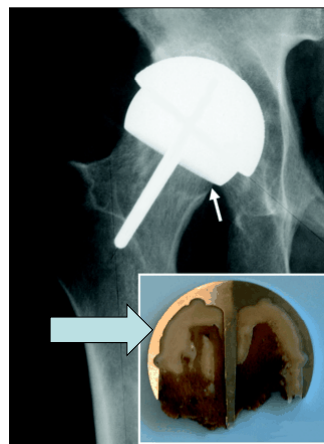
Femoral component not seated

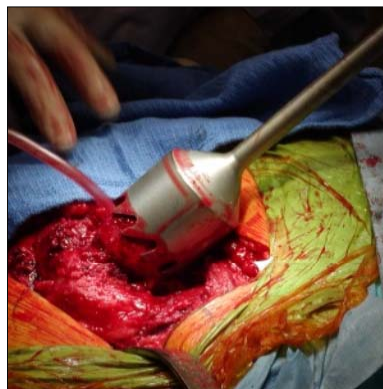
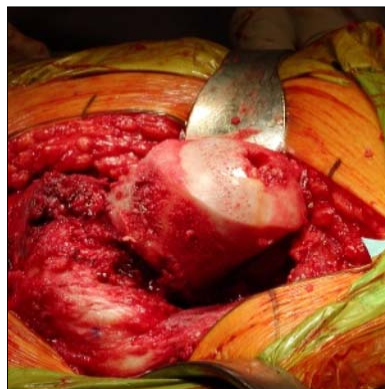
Precise femoral reaming

Stem should be parallel to calcar, not centered on neck!

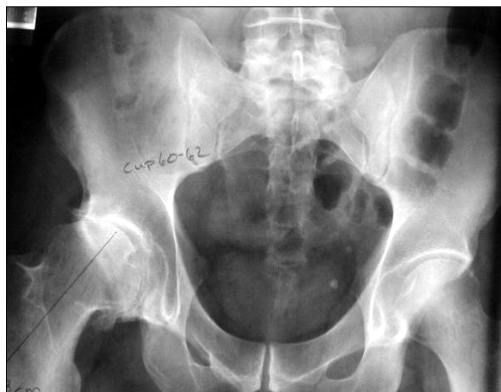
OA pre-op

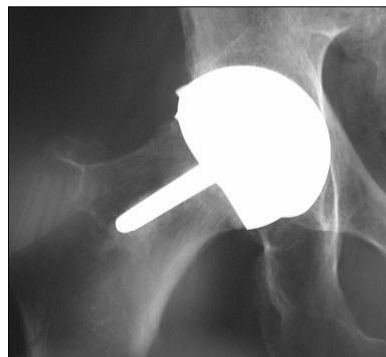
34 mo post-op

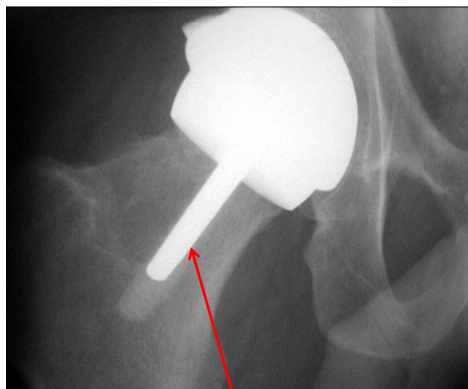
E.L. 6 weeks post-op

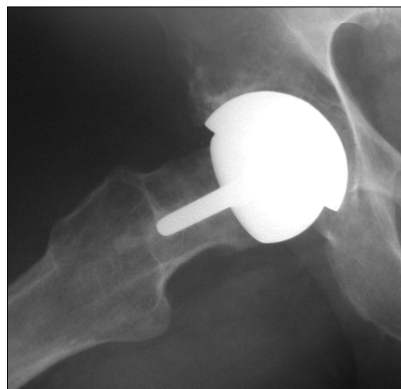
Correct Stem position

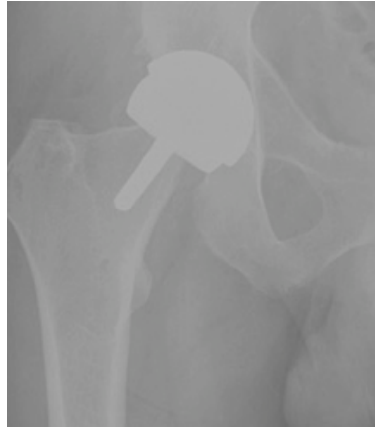
Neck Thinning CTQ

- Thought to be stress shielding
- Unknown consequences
- Patients don't have pain
